Campden BRI

Investigation of Corrosion on External Surface of Cans

Work performed by Campden BRI (Chipping Campden) Limited
Report number: MI/REP/180010-00024/1 ♦ Issue date: 20th April 2018

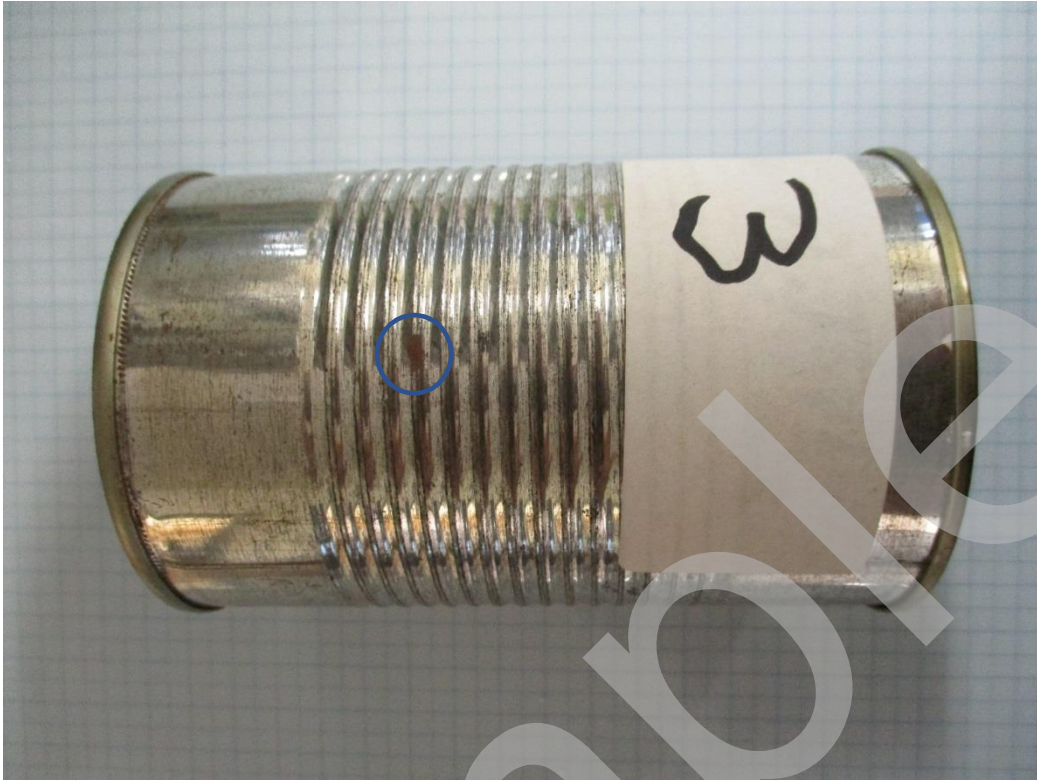
A single, opened, empty can was received by the Microscopy section, for the investigation of external corrosion. The client had stated that the same type of corrosion had been seen in multiple locations on numerous cans. The can was photographed as received and can be referred to in Plate 1.

PLATE 1 Shows the complaint can photographed as received to show the presence of corrosion on the body (circled), against a millimetre-squared background

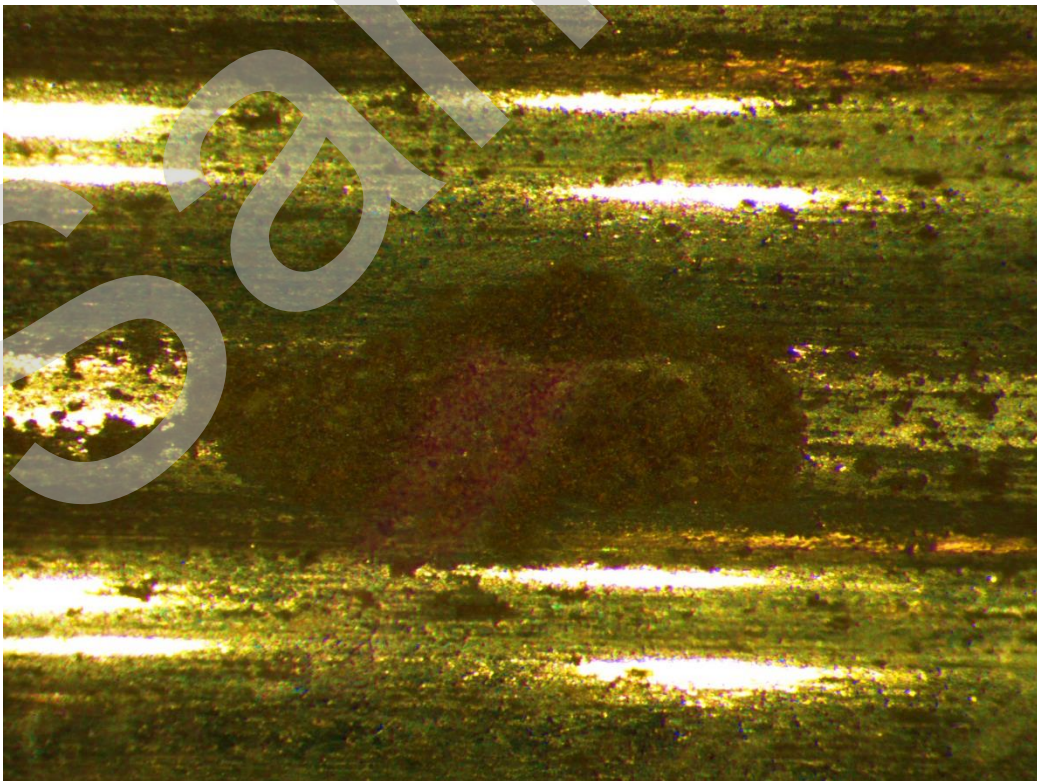
Examination visually and under a stereomicroscope showed that the corrosion was contained to a single area on the body of the can (Plate 2). No hole could be seen in this area and no corrosion was seen internally.

PLATE 2 Shows a close up of the area showing corrosion viewed under stereo-microscope. (Note the gold colour effect to the can is an artefact of light)

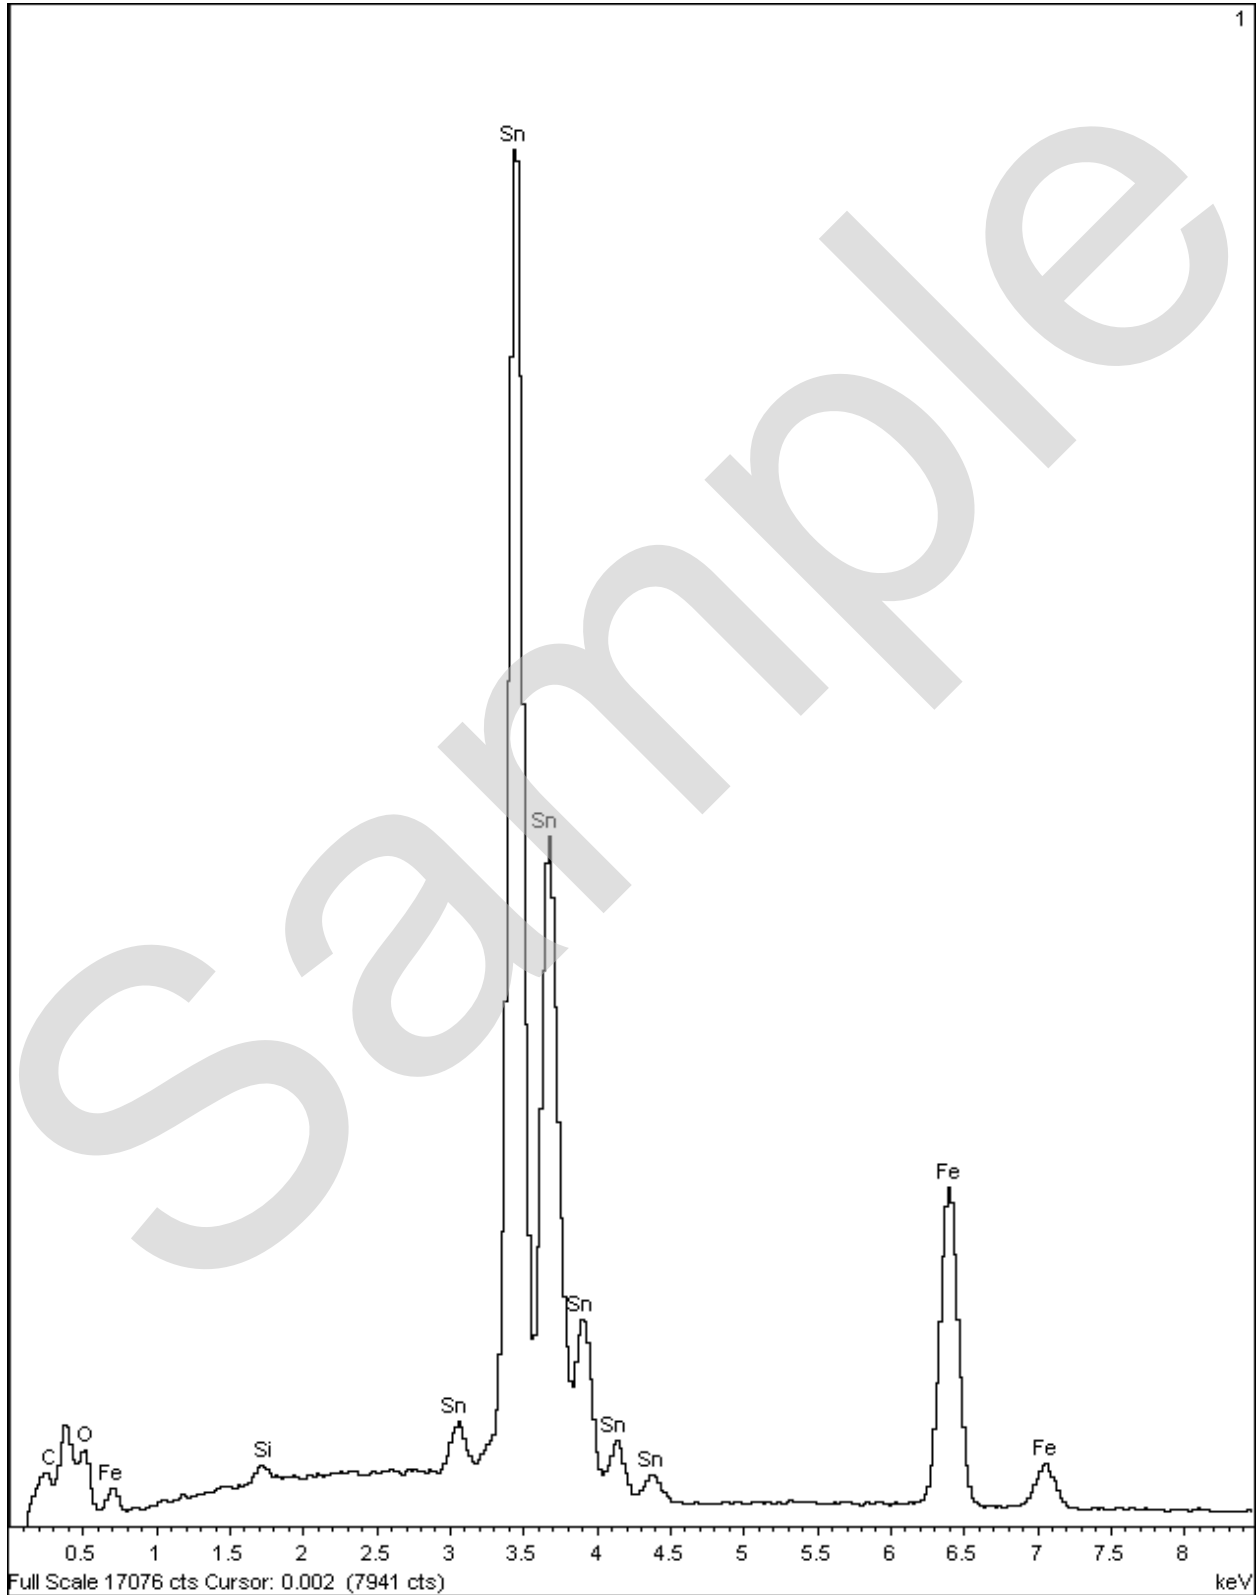
A reference area and the area showing the corrosion were examined using x-ray microanalysis. The reference area showed the presence of carbon, oxygen, iron, silicon and high peaks of tin (Figure 1). The area showing corrosion showed the presence of carbon, high peaks of oxygen, higher peaks of iron, silicon, chlorine and reduced peaks of tin; trace amounts of sodium, magnesium, aluminium, phosphorus and sulphur were also seen (Figure 2). Together these spectra confirm the absence of a tin coating and exposure of steel in the corroded area. The corroded area also showed the presence of chlorine, which is commonly found in cooling water.

LIMS Project Number : 180423-00919
Reference area of the complaint can

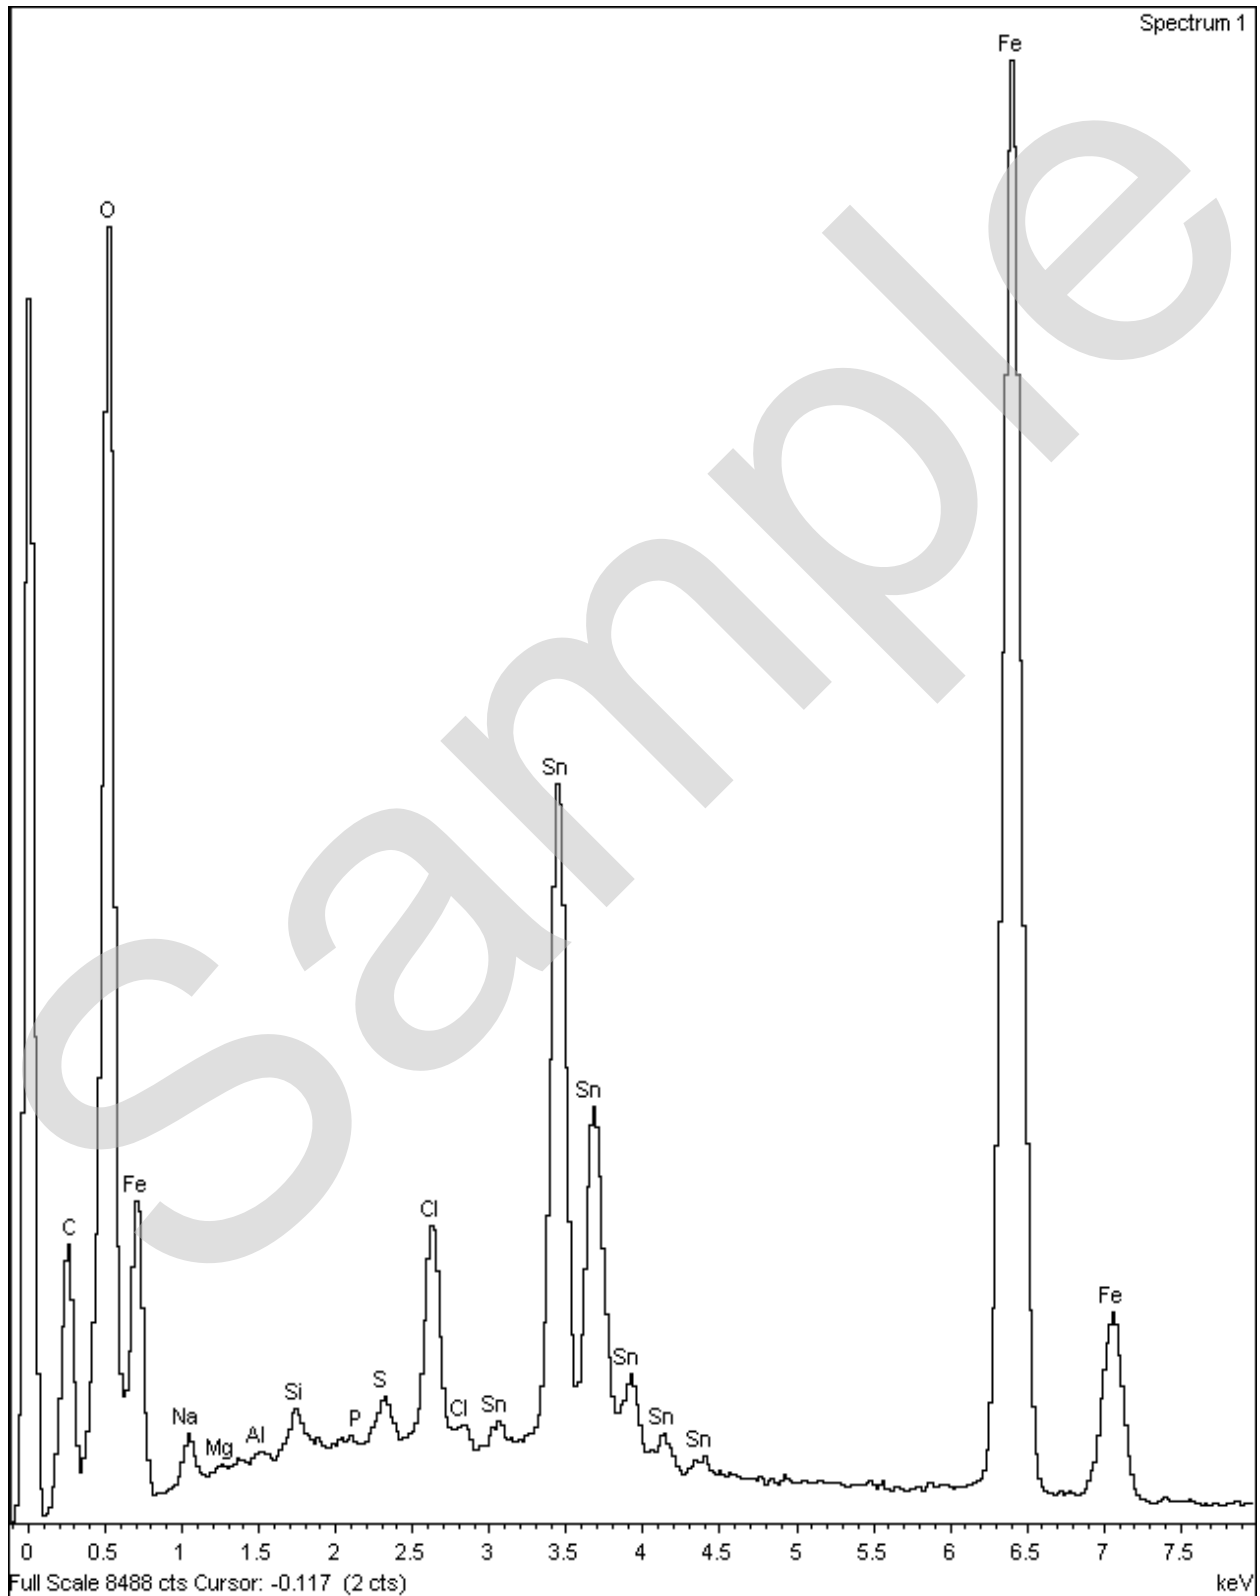
It was concluded that the can submitted for analysis showed corrosion in one area on the body of the can, the corrosion was restricted to the surface only and no hole or internal corrosion was seen. Elemental analysis showed the presence of chlorine in the corroded area, chlorine residues from water treatment left on the surface of a can, followed by insufficient drying techniques can lead to corrosion. Due to the level of chlorine exhibited in the corroded area this was thought to be the cause of the corrosion.

LIMS Project Number : 180423-00919
Area showing corrosion of the complaint can
