Instrument Assessment Report

Unison Engineering Service Ltd

Assessment of the Pastest Heat Exchanger Test Unit

Appraisal Of Unison Engineering Technology Ltd's Technology For Integrity Testing Of Plate Heat Exchangers

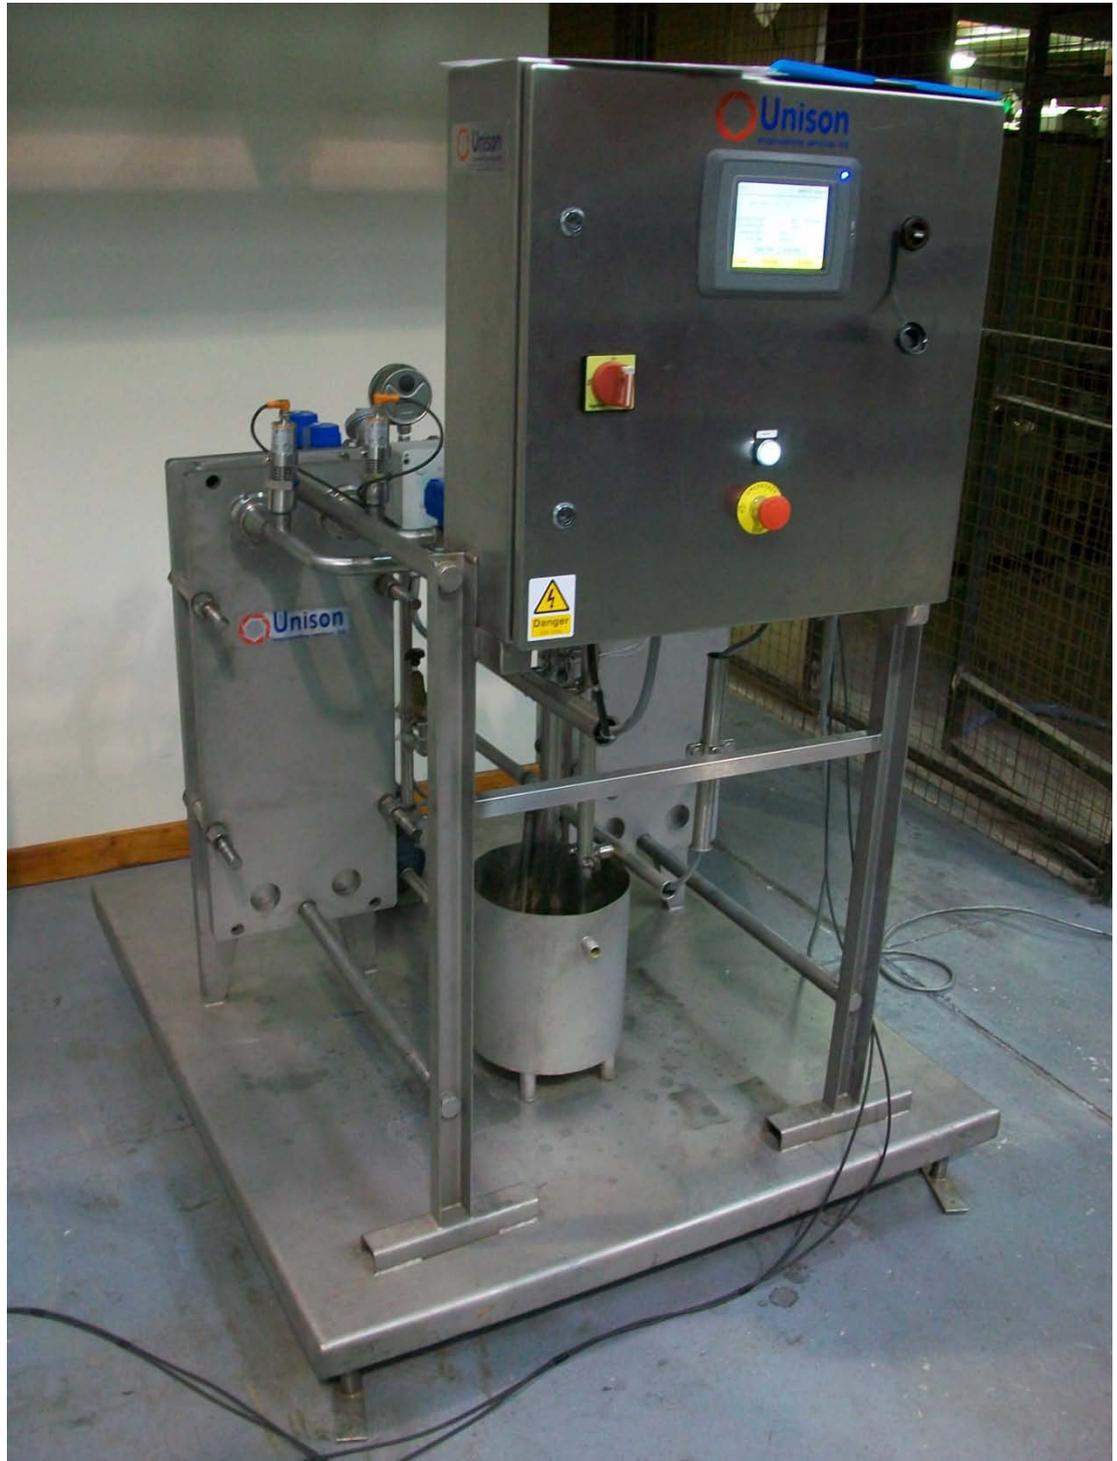
The test unit at Unison. The small vessel bottom middle enabled recycling around the high pressure side. There are two plate heat exchanger units although only one was required for these tests.

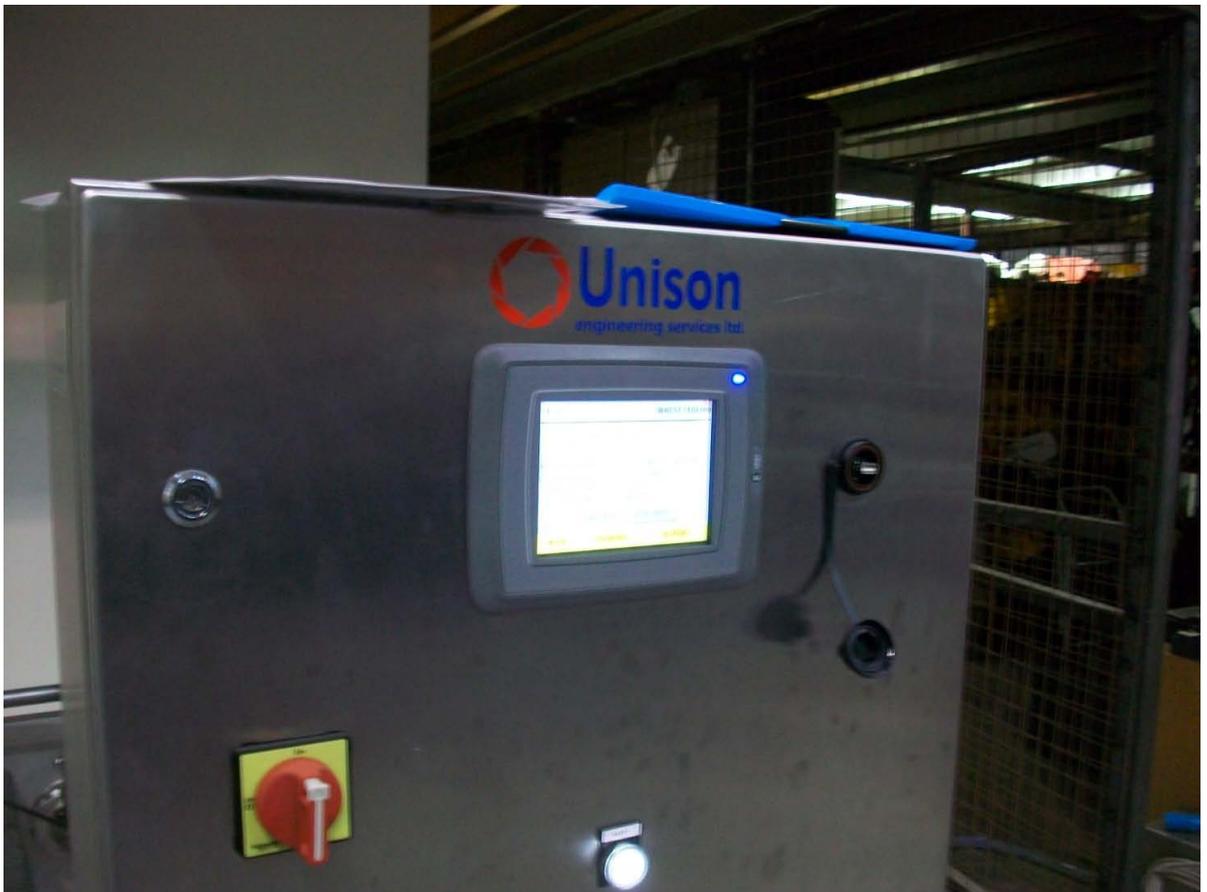
The unit had a clear operating screen and graphical output of the test results. Also a USB output for removal of data.

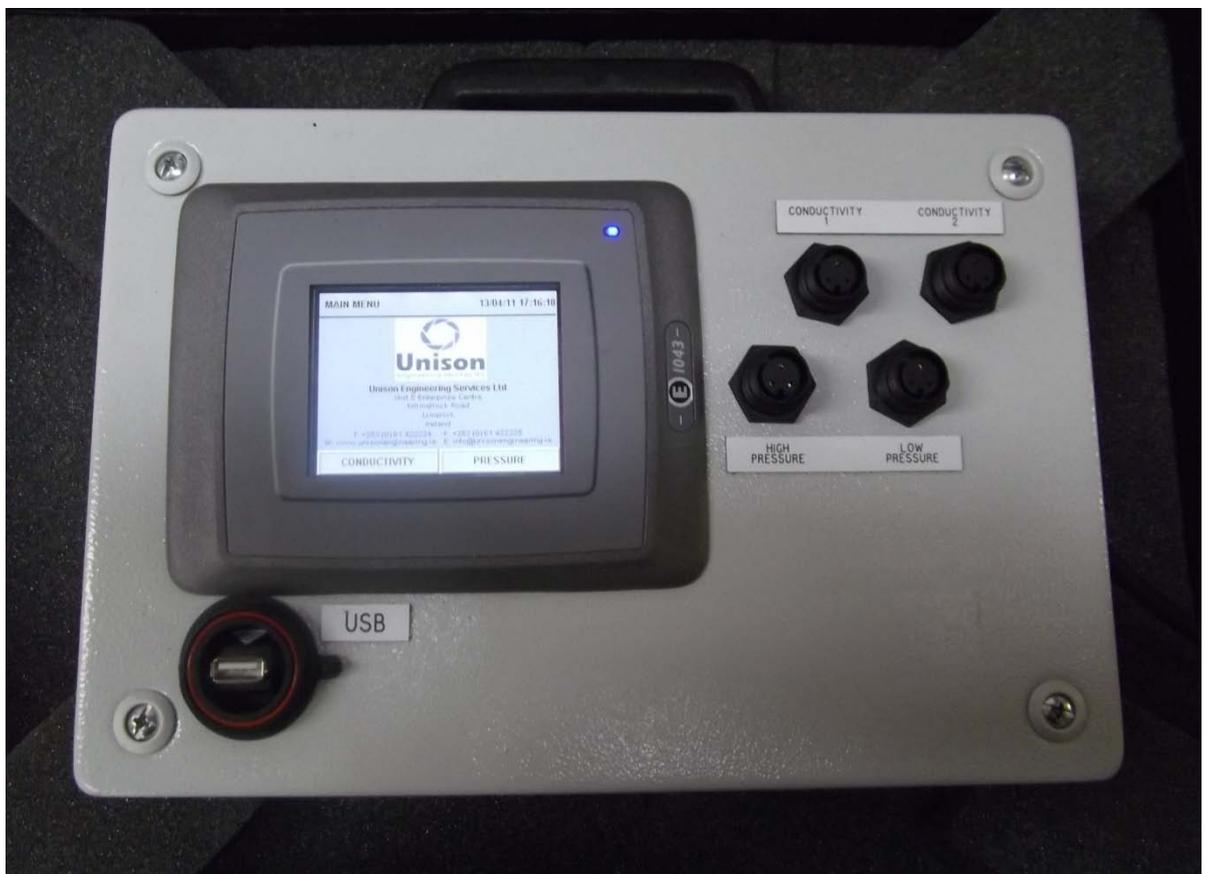
This is a portable unit that enables effective site work.

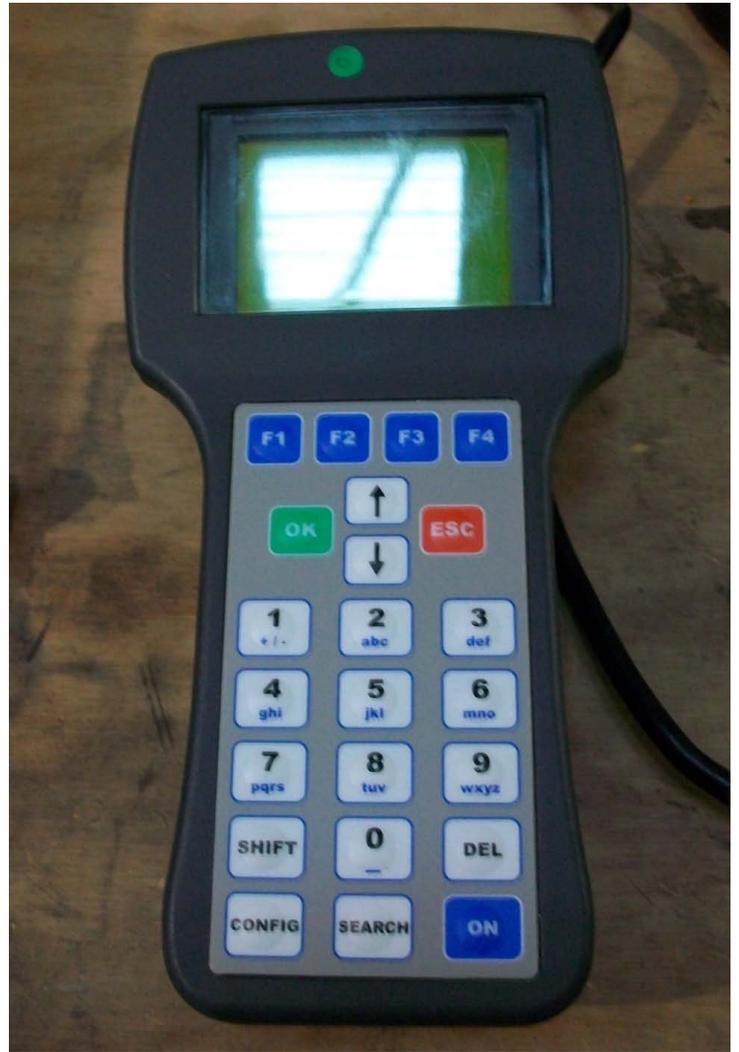
A new portable unit has been designed that is smaller than the previous one.

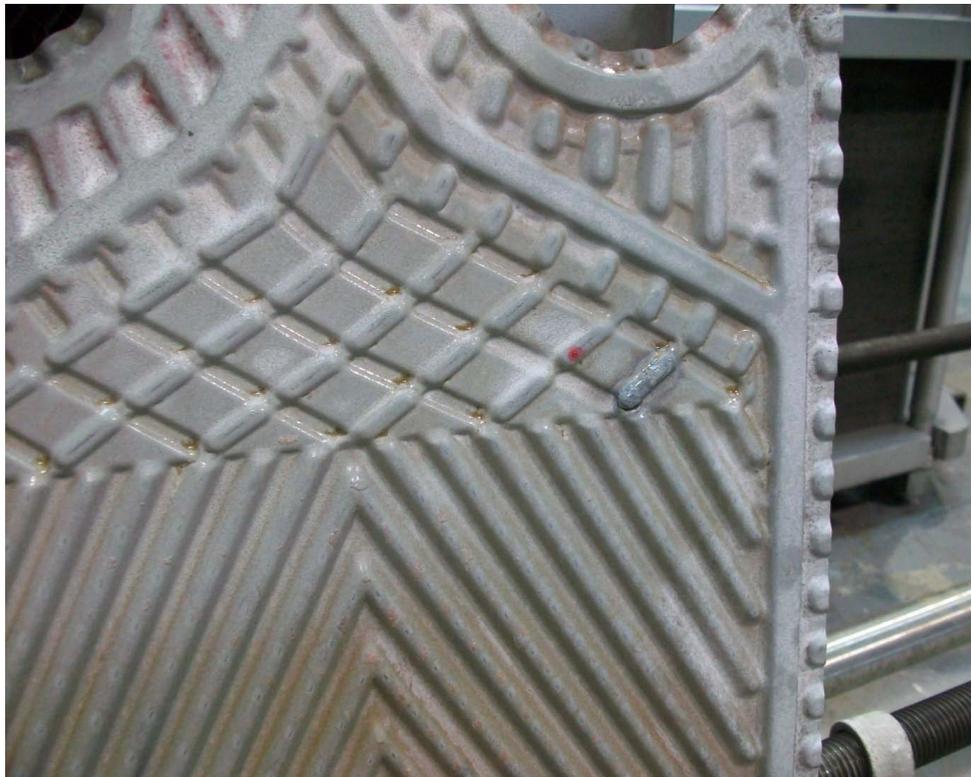
Part way through the trials the leaking plate was removed for visual inspection of the orifice. This photograph was taken after dye testing and the orifice can be seen close to the centre of the photograph. Red dye was sprayed on the opposite side and the facing side was cleaned. The orifice was barely detectable without dye testing.

- One of the plates has a deliberately set hole that was a maximum 200 μ m in diameter when it was drilled. It was observed to be still smaller than a 400 μ m gauge.
- The unit was tested for a range of pressure differences, run times and pass/fail set points. It was also tested with and without the plate with a leak. All heat exchanger integrity tests may be performed with process water, there is no advantage to using e.g. product.

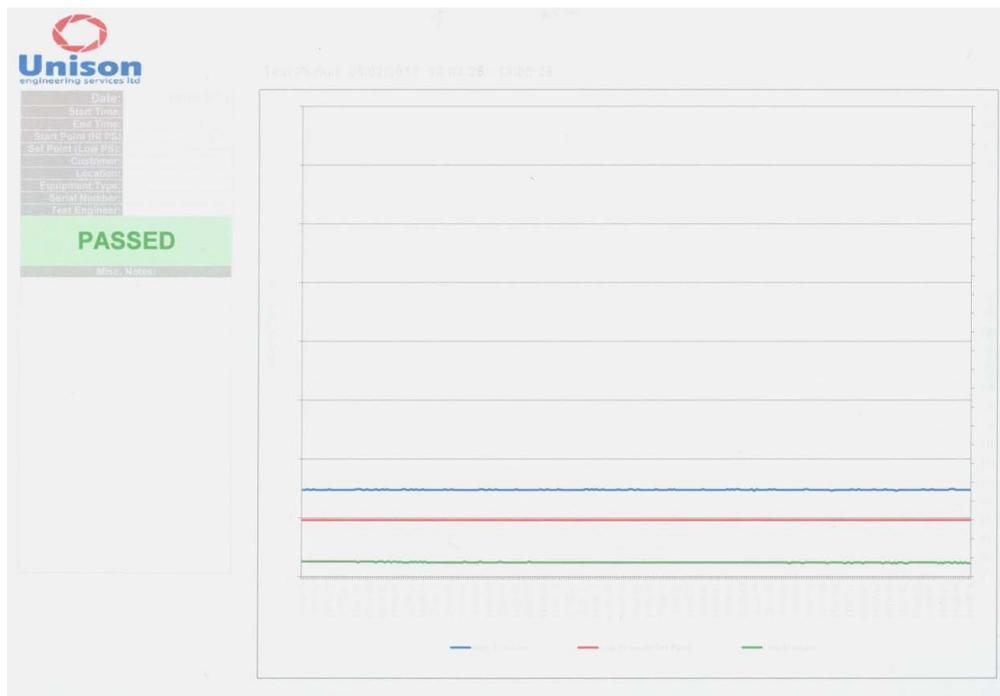
Leaking plate fitted. Pressure difference 1.471 bar, set point 60 mbar. Blue line high pressure side pressure, red line low pressure side set point, green line low pressure side pressure. At this low pressure difference no leak detected.

The results seemed to suggest that at least 3 bar pressure was required to drive the water through the 200µm orifice. It was perceived as very likely that liquid flow would not occur through such a small orifice unless a minimum pressure difference was set.

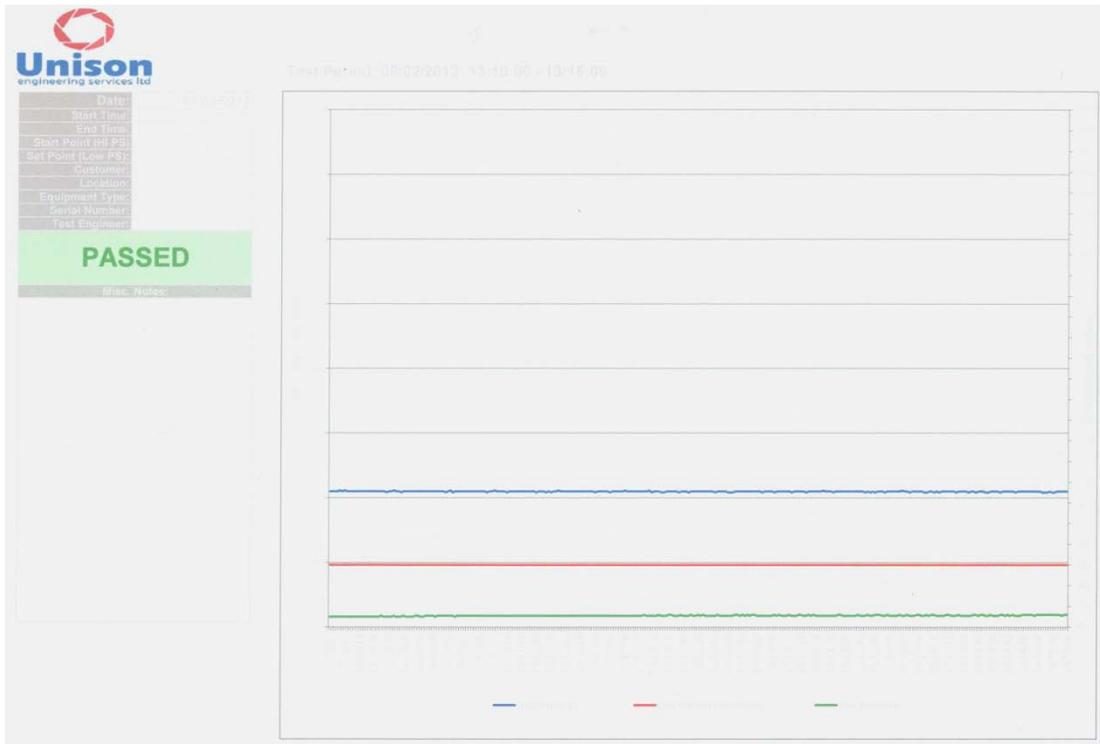
Leaking plate fitted. Pressure difference 2.097 bar, set point 60 mbar. Blue line high pressure side pressure, red line low pressure side set point, green line low pressure side pressure. At this low pressure difference no leak detected.

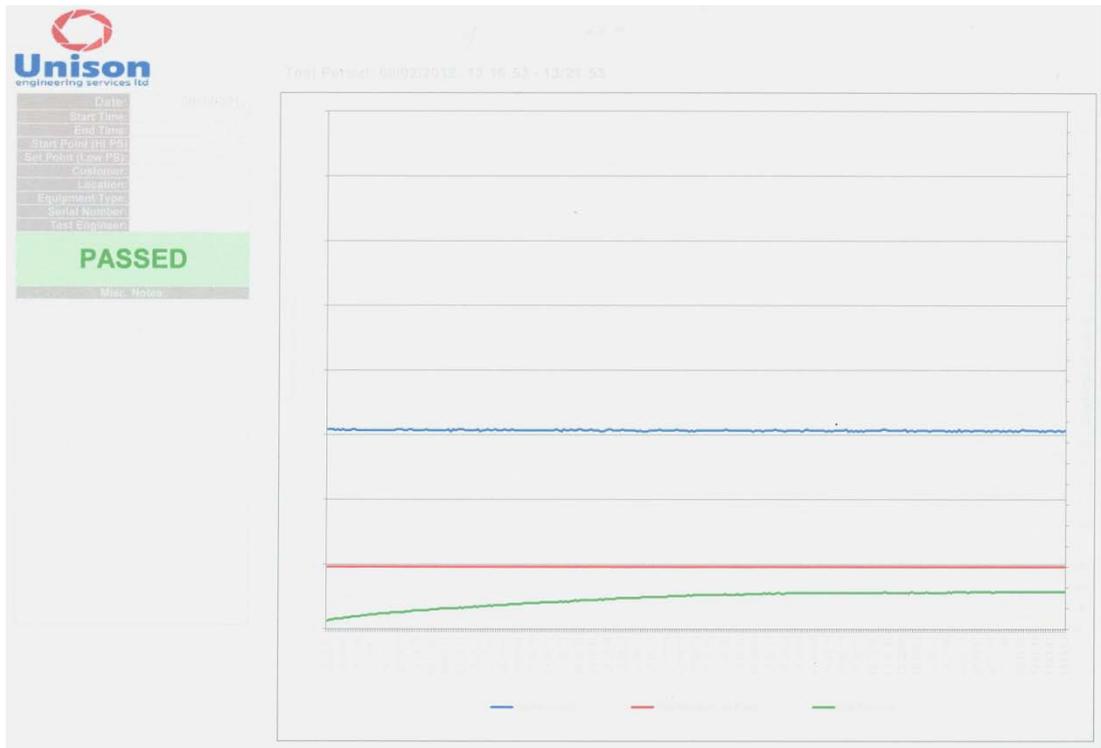
Leaking plate fitted. Pressure difference 3.083 bar, set point 60 mbar. Blue line high pressure side pressure, red line low pressure side set point, green line low pressure side pressure. At this pressure difference there is leaking detected, but it does not reach the set point without an extended run time. However, the operator would see from the graph that the run parameters need adjusting and re-test.

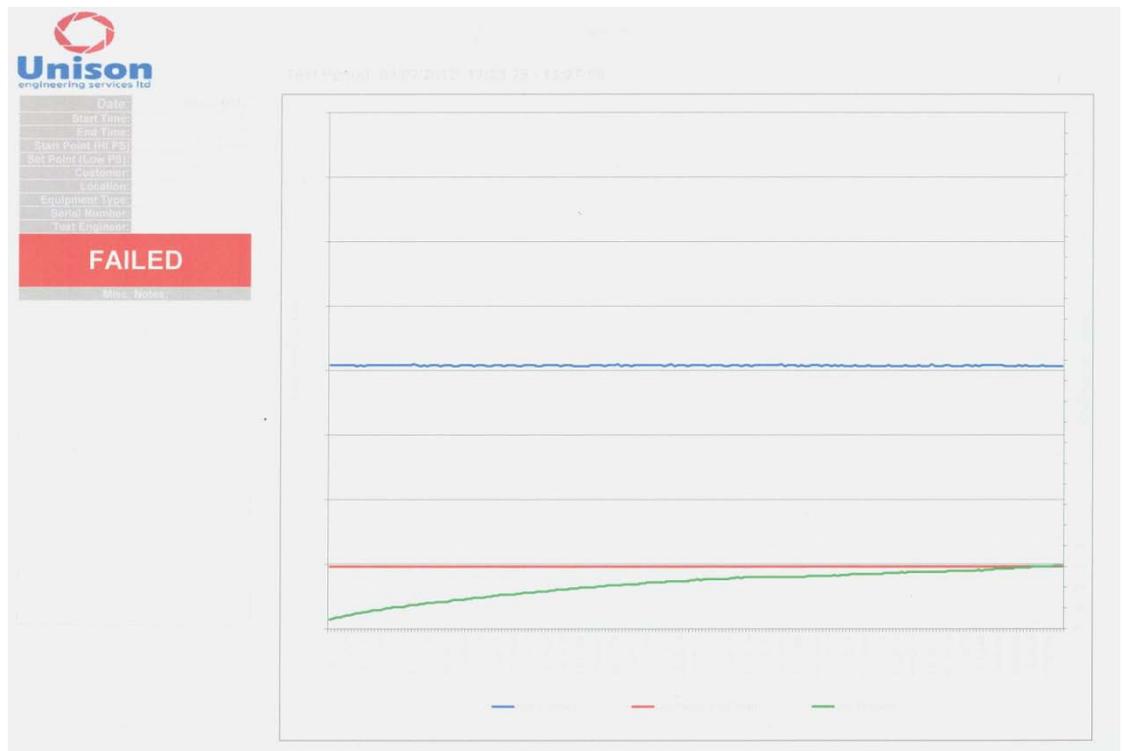
Leaking plate fitted. Pressure difference 4.084 bar, set point 60 mbar. Blue line high pressure side pressure, red line low pressure side set point, green line low pressure side pressure.

The fact that the unit detects the small leak at pressure difference at least 4 bar illustrated that the leak was not active at pressures less than this. Conceptually the heat exchanger would operate properly at below 4 bar differential pressure. However, such operation would not fit well with many HACCP systems. Also the leak is likely to get worse. Therefore this highlights again the "early warning" benefit of the unit.

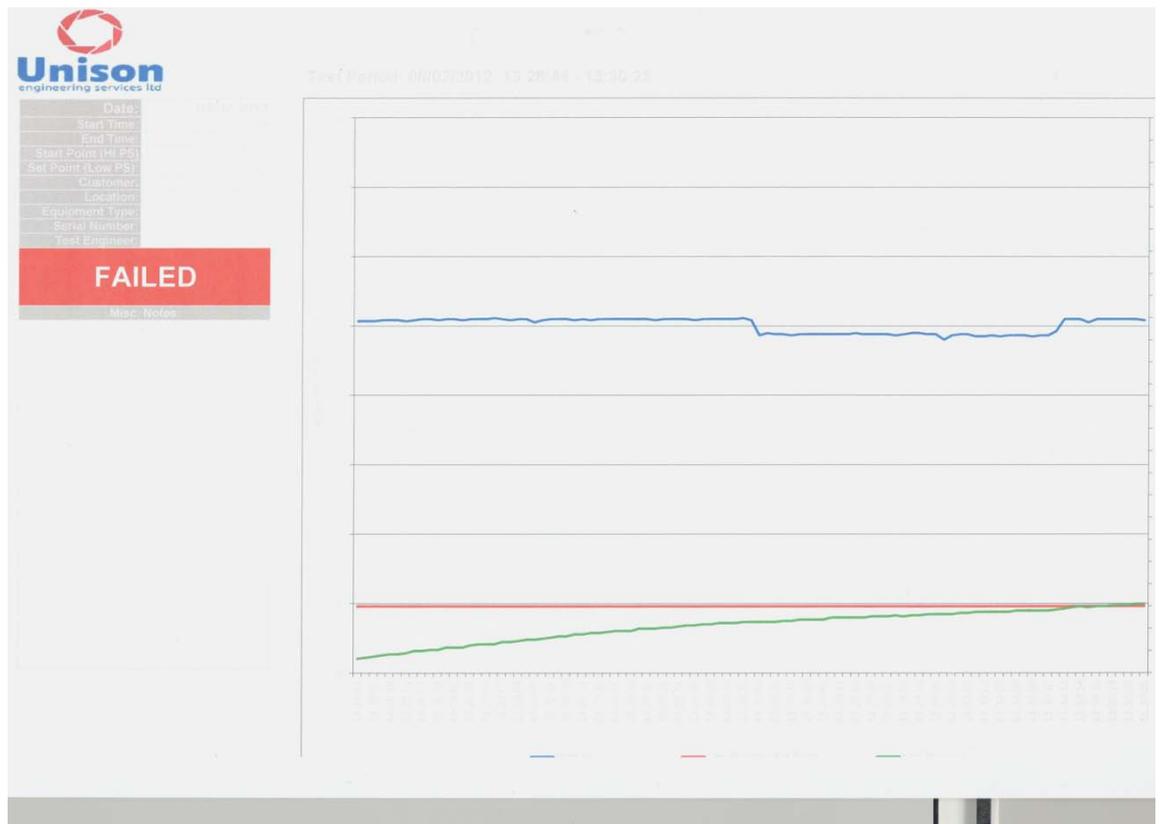
Leaking plate fitted. Pressure difference 5.07 bar, set point 60 mbar. Blue line high pressure side pressure, red line low pressure side set point, green line low pressure side pressure.

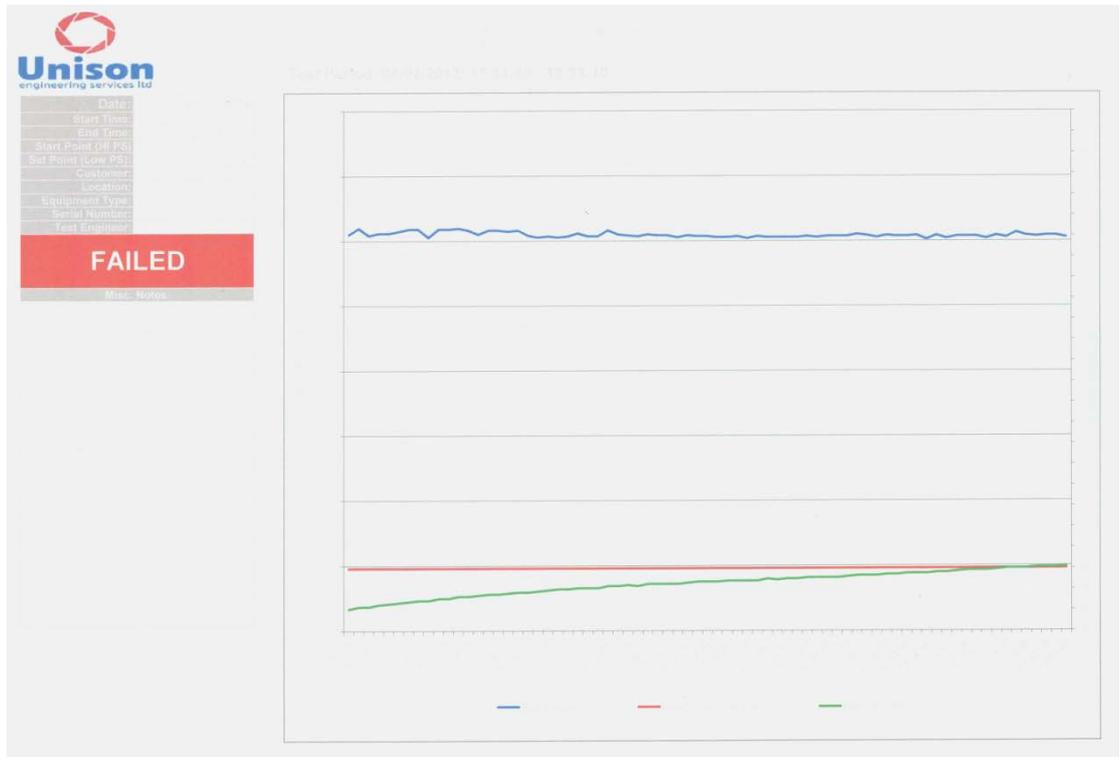
Leaking plate fitted. Pressure difference 6.103 bar, set point 60 mbar. Blue line high pressure side pressure, red line low pressure side set point, green line low pressure side pressure.

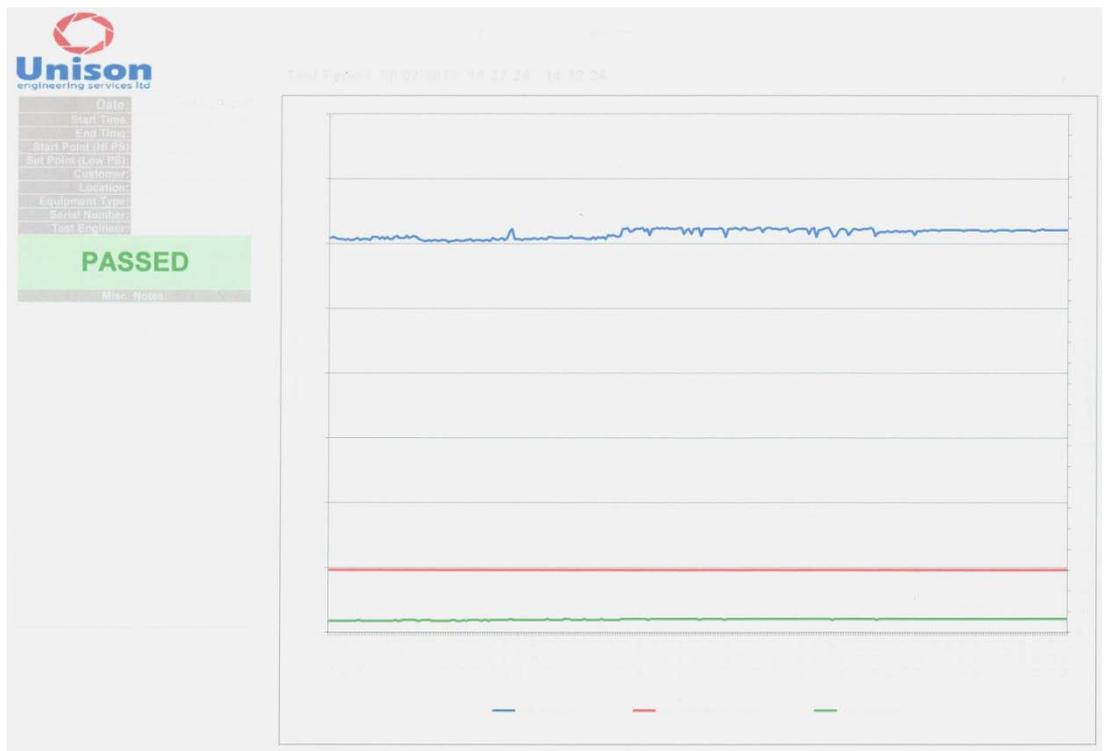
Leaking plate removed. Pressure difference 6.087 bar, set point 60 mbar. Blue line high pressure side pressure, red line low pressure side set point, green line low pressure side pressure. Correct operation confirmed.
