Campden BRI

Examination of a Capsule Reported from Elderflower water

Report number: EM/REP/181302-06635/3 ♦ Issue date: 1st February 2018

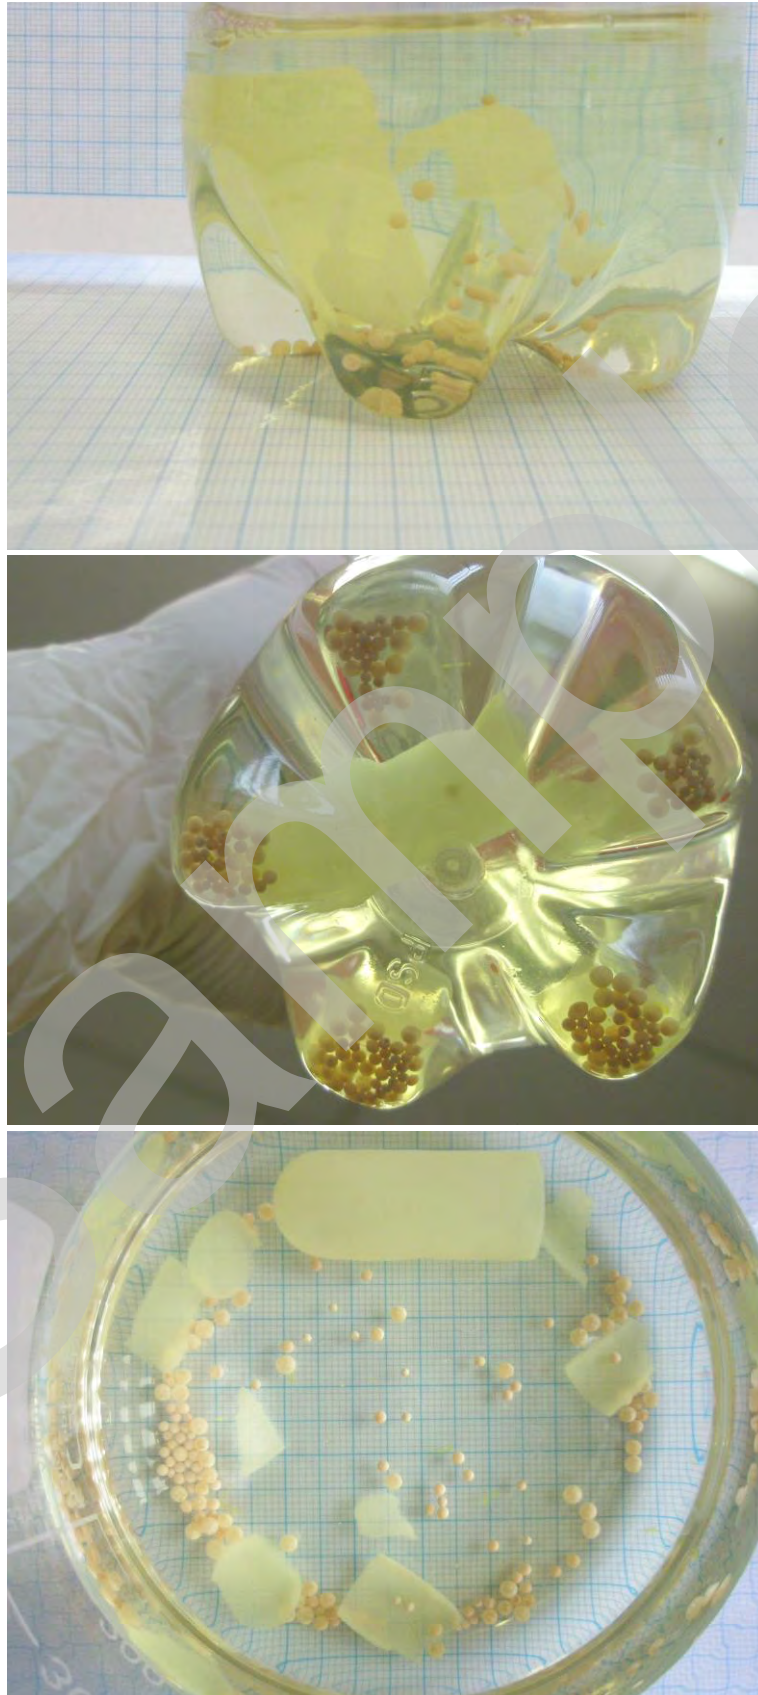
PLATE 1 Shows the remains of the capsule settled at the bottom of the bottle of elderflower water (top and middle) and decanted into a glass beaker (bottom). Note the yellow/green tinge of the liquid

The complaint sample consisted of a pre-opened bottle of elderflower water, which was reported to contain a capsule. The capsule was removed from the bottle, decanted into a glass beaker and photographed which can be referred to in Plate 1.

On visual inspection it was possible to see numerous light brown/cream coloured spansules and the remains of a bright yellow coloured capsule casing settled at the bottom of the bottle (refer to Plate 1). The liquid itself had a green/yellow tinge, considered most likely to have resulted from the colouring of the capsule casing leaching out. Approximately 200ml of the liquid remained in the bottle.

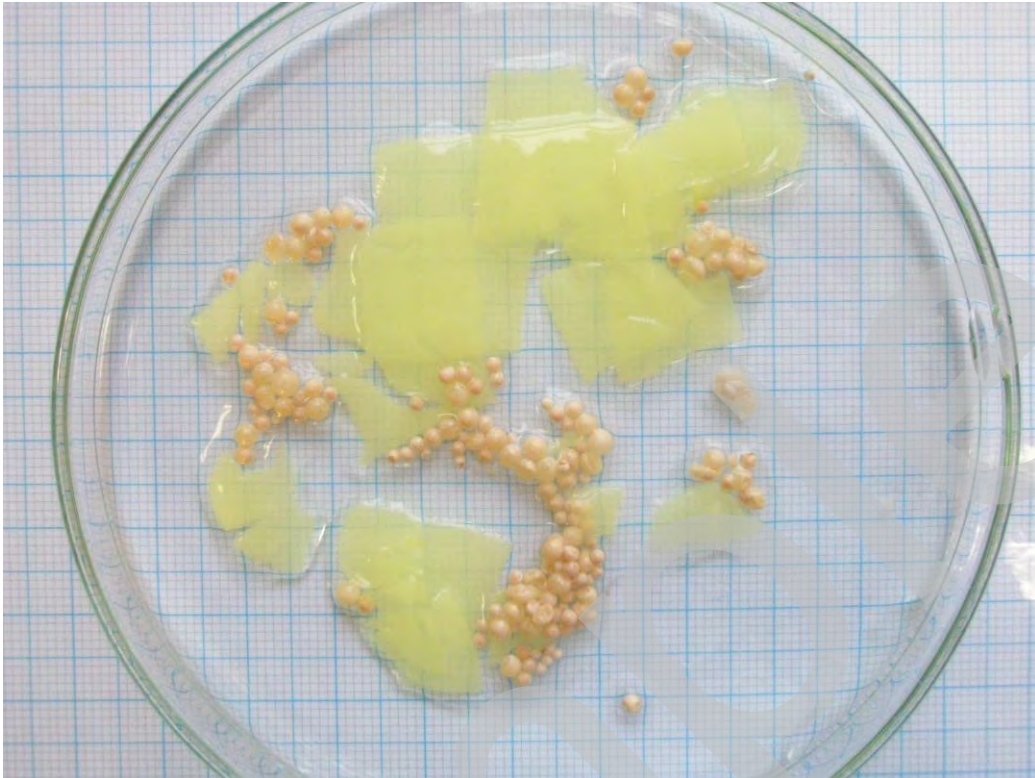
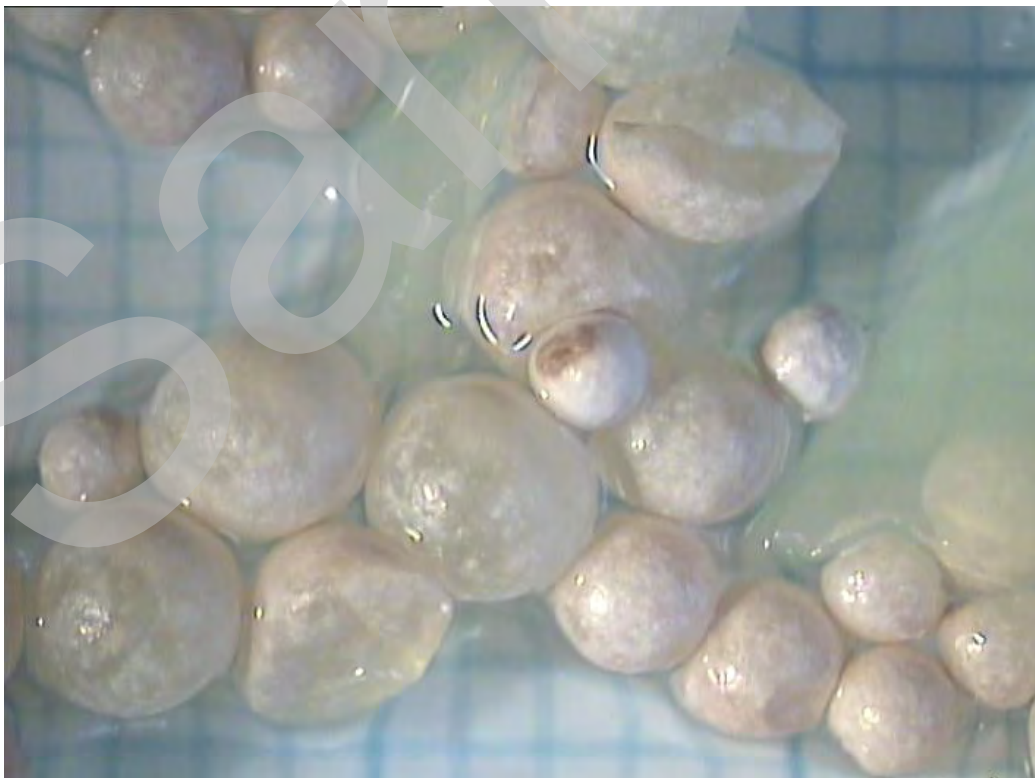
PLATE 2 Shows the remains of the capsule on a glass Petri dish (top) and the variable sizes and shapes of the spansules (bottom), both photographed against a millimetre-squared background

The remains of the capsule were removed from the liquid for examination under the stereo microscope (Plate 2). Here the capsule casing was seen to have softened considerably and the spansules were of variable sizes and shapes (some had a deflated appearance). No markings were present on the capsule casing to assist in identification.

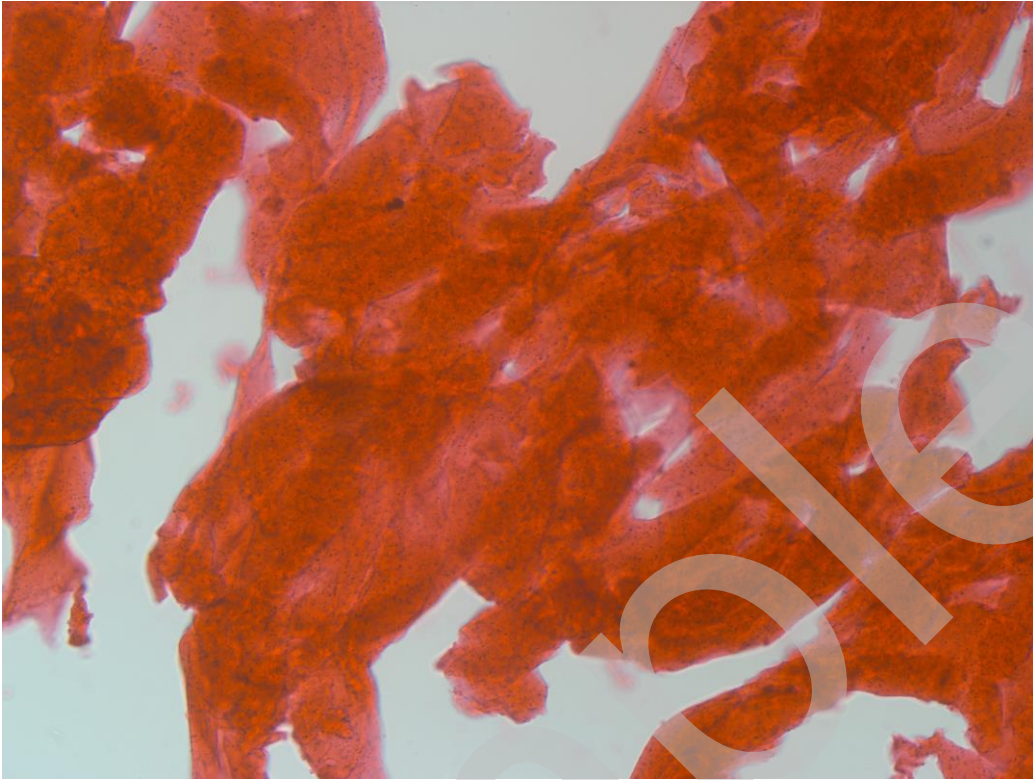
PLATE 3 Shows a section of the capsule casing stained positively for the presence of protein with eosin solution. Magnification x 220

A section of the capsule casing was examined under the compound microscope. Here it was seen to have a speckled appearance and stained positively for the presence of protein following the addition of eosin solution (Plate 3). A couple of the spansules were also examined under the compound microscope. Here they were seen to contain maize starch, a commonly used excipient/bulking agent in tablets and capsules (Plate 4).

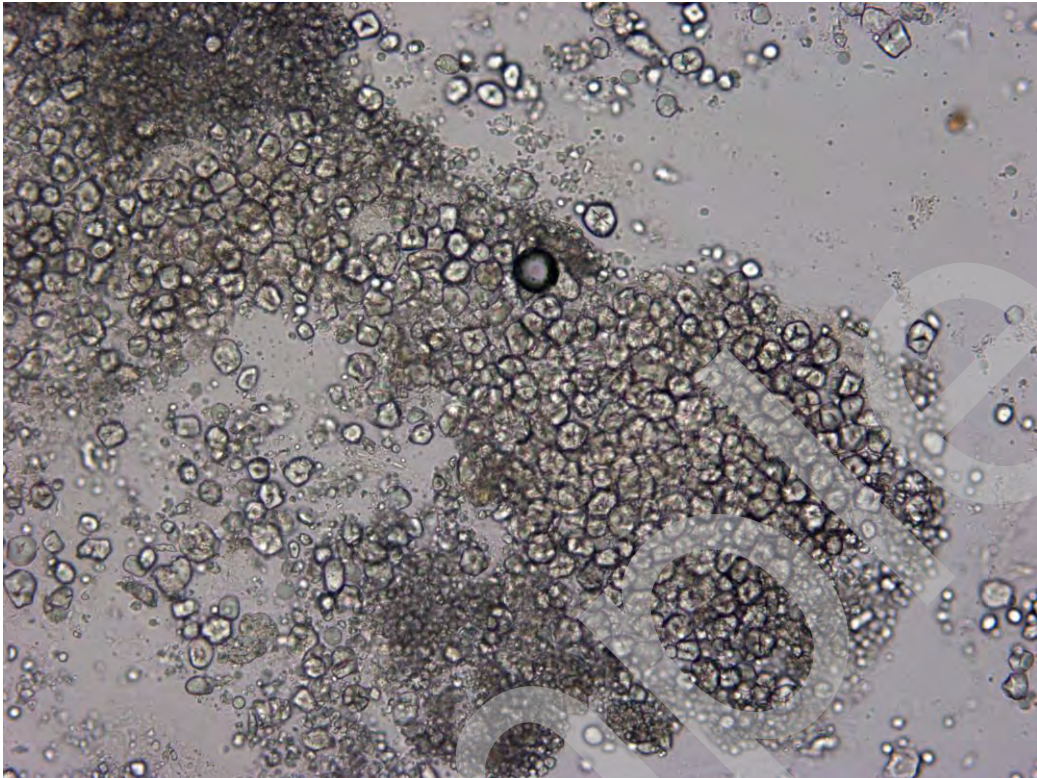
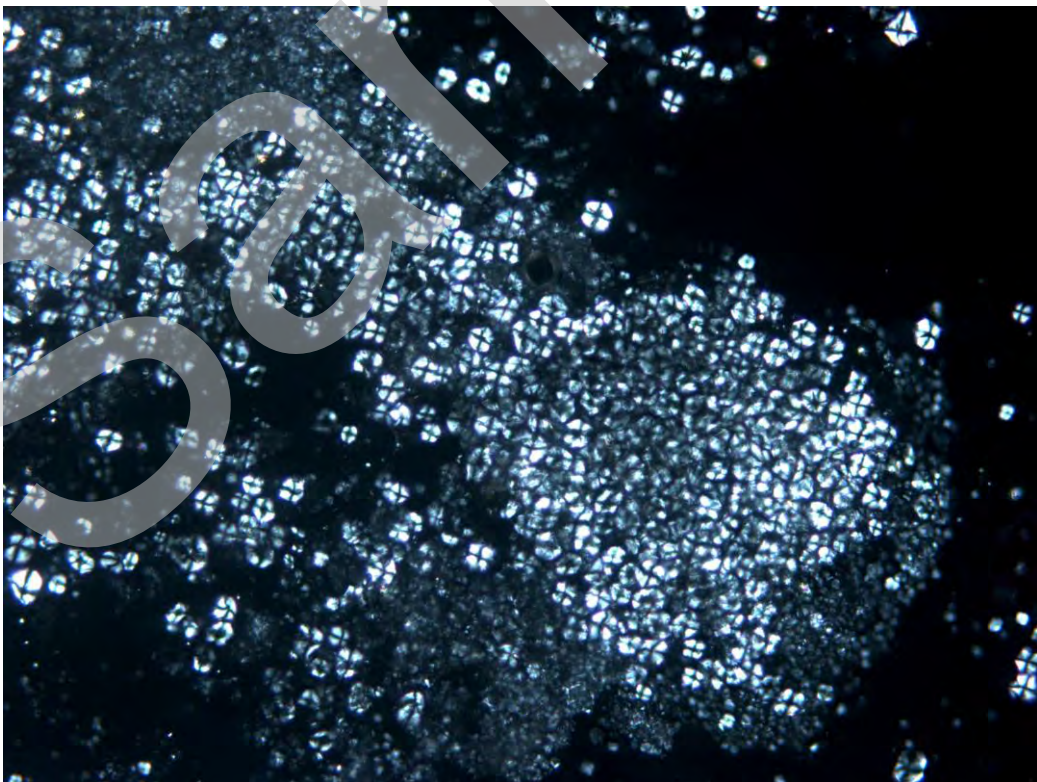
PLATE 4 Shows some of the maize starch granules present in the spansules, as viewed under bright field light (top) and under polarised light (bottom). Magnification x 220

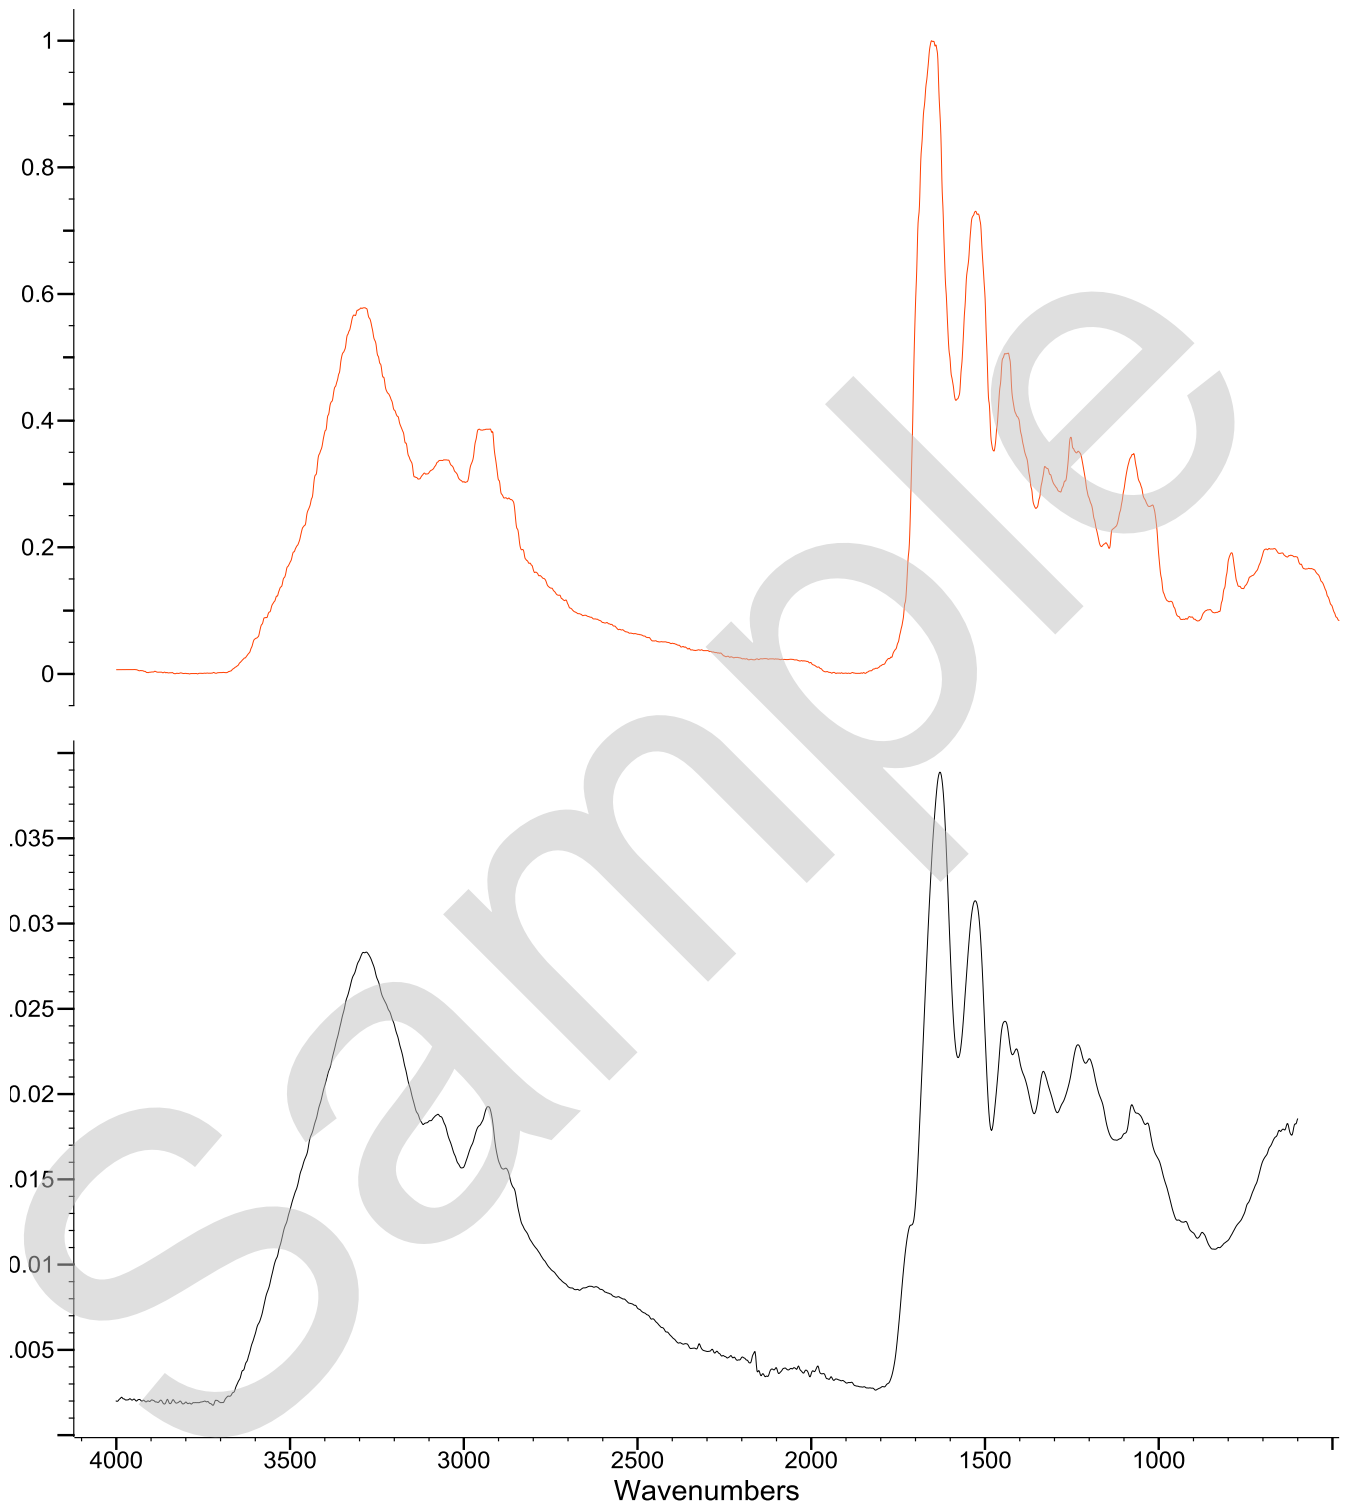
FIGURE 1

Top spectrum : Gelatine
Bottom spectrum : Complaint Sample

FT-IR spectroscopy was performed on both the capsule casing and the spansules. A good match in the reference libraries was found with gelatine for the capsule casing (Figure 1), however a match to an active ingredient could not be obtained for the spansules.
